## **URGENT SAFETY ALERT**

**TGA Recall Reference Number RC-2024-RN-00503-1**  
**ZOLL Medical G5 Semi-Automatic AED Product Family**

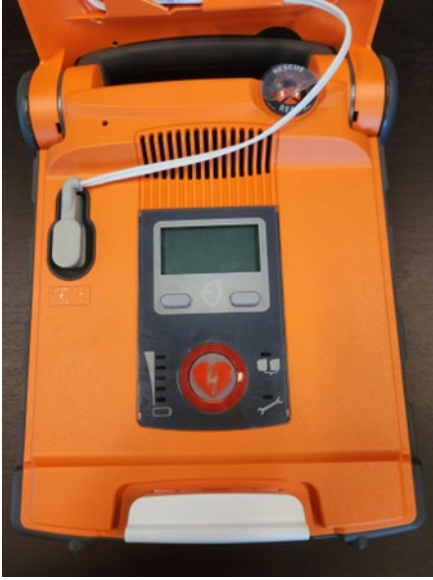
**Figure 1:** Device with the protective film over the front panel, if present.

The G5 Semi-Automatic AED is shipped with a protective film over its front panel to protect the screen and shock button from cosmetic damage during shipping. It has come to our attention that customers may not be removing the protective film during deployment of the product. If the protective film is left adhered to the front bezel it may prevent the user from actuating the shock button. This may lead to a delay or prevent delivery of defibrillation therapy to a victim suffering from sudden cardiac arrest.

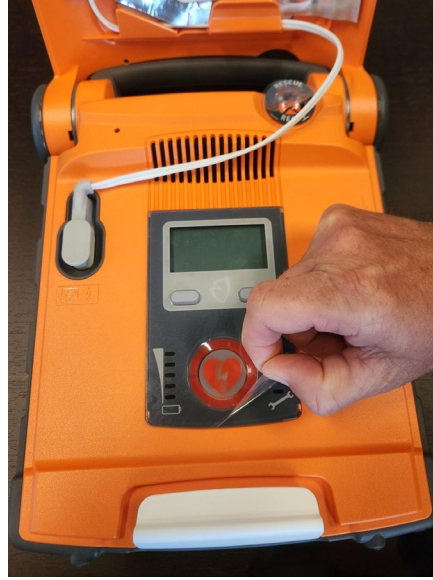
**Figure 2:** Remove the protective film by lifting it from its edge, if present.

- (1) Inspect your stock immediately and identify if any of the serial numbers within the serial number range is within your stock. Ensure all packaging material, including the screen protective film is removed.
- (2) Complete the attached Customer Response Form, even if you do not have any affected stock and email it to [tmerry@zoll.com](mailto:tmerry@zoll.com) as soon as possible so ZOLL can reconcile this process.
- (3) Ensure relevant staff members are informed of this safety alert, to ensure they are aware of the safe distance requirements and are trained to these guide updates.
- (4) If you have supplied or transferred any potential affected G5 Semi-Automatic Defibrillator to another facility or organisation, provide that facility with a copy of this letter immediately.
- (5) Place this letter in a prominent position for at least one month.

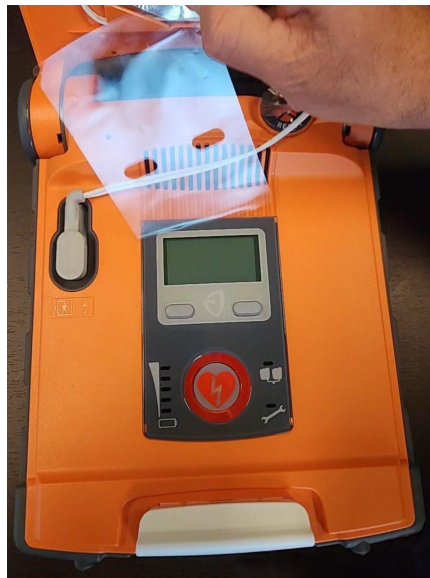
**Figure 3:** Discard the protective film.
